# Site Review And Update

SOUTH ANDOVER SITE

ANDOVER, ANOKA COUNTY, MINNESOTA

OCTOBER 19, 1994

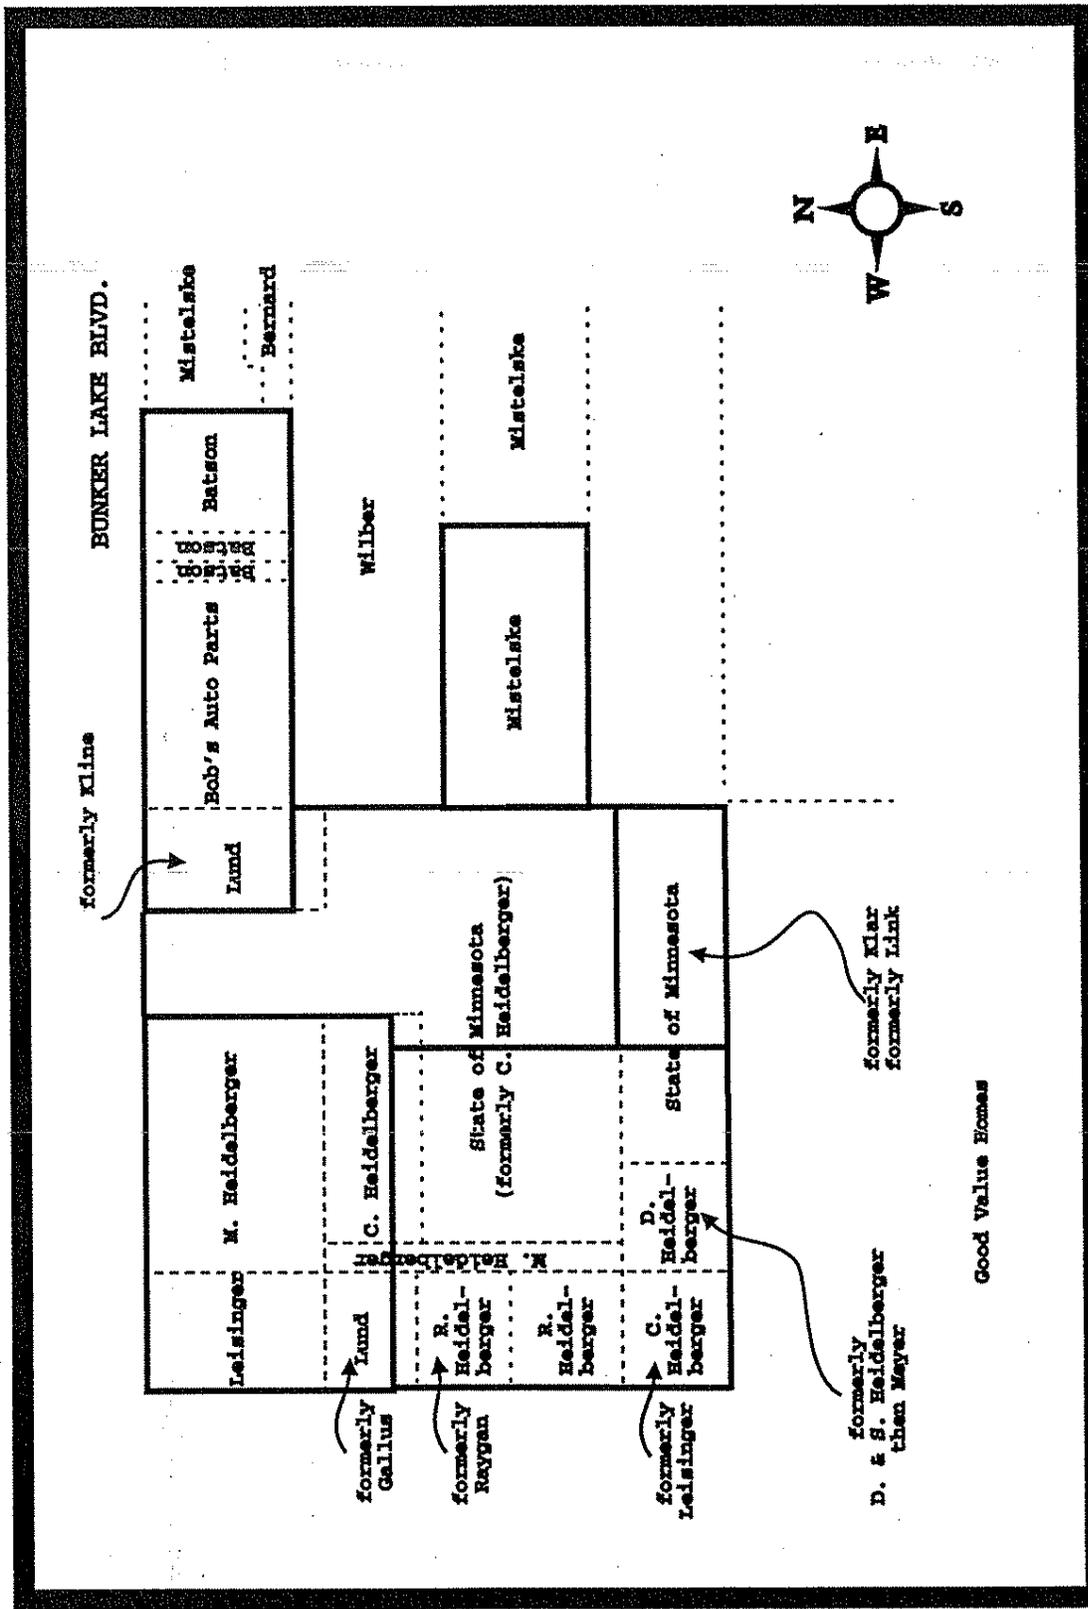
Figure 6. Property Ownership (past and present as given in site file documents)

The parcels (see Figure 6) comprising the Site were used by their owners for varied disposal activities. The following activities were reported in Site documents for the respective areas designated by ownership:

- Heidelberg property -- Areas were used for storage and disposal (dumping, sale

of decantable liquids, and possible burning) of drummed chemical wastes, junk auto and scrap storage, and stockpiling of an estimated 3 million tires. A smelter was formerly located on the portion of property purchased by Kline.

- Batson property -- Portions were used for open pit burning of thousands of barrels of solvents and inks. A wetland on the western portion of the parcel was allegedly used for dumping liquids before it was filled.
- Mistelske property -- This property was used for storage of thousands of gallons of paints, grease, and adhesives in containers.
- Meyer (formerly S. and D. Heidelberger) property -- Drums of chemical wastes stored and spilled along the northern side of the parcel.
- Klar (formerly Link) property -- This property was used for drummed waste storage, salvage material storage, transformer and electrical equipment storage, and was the location of a smelter.

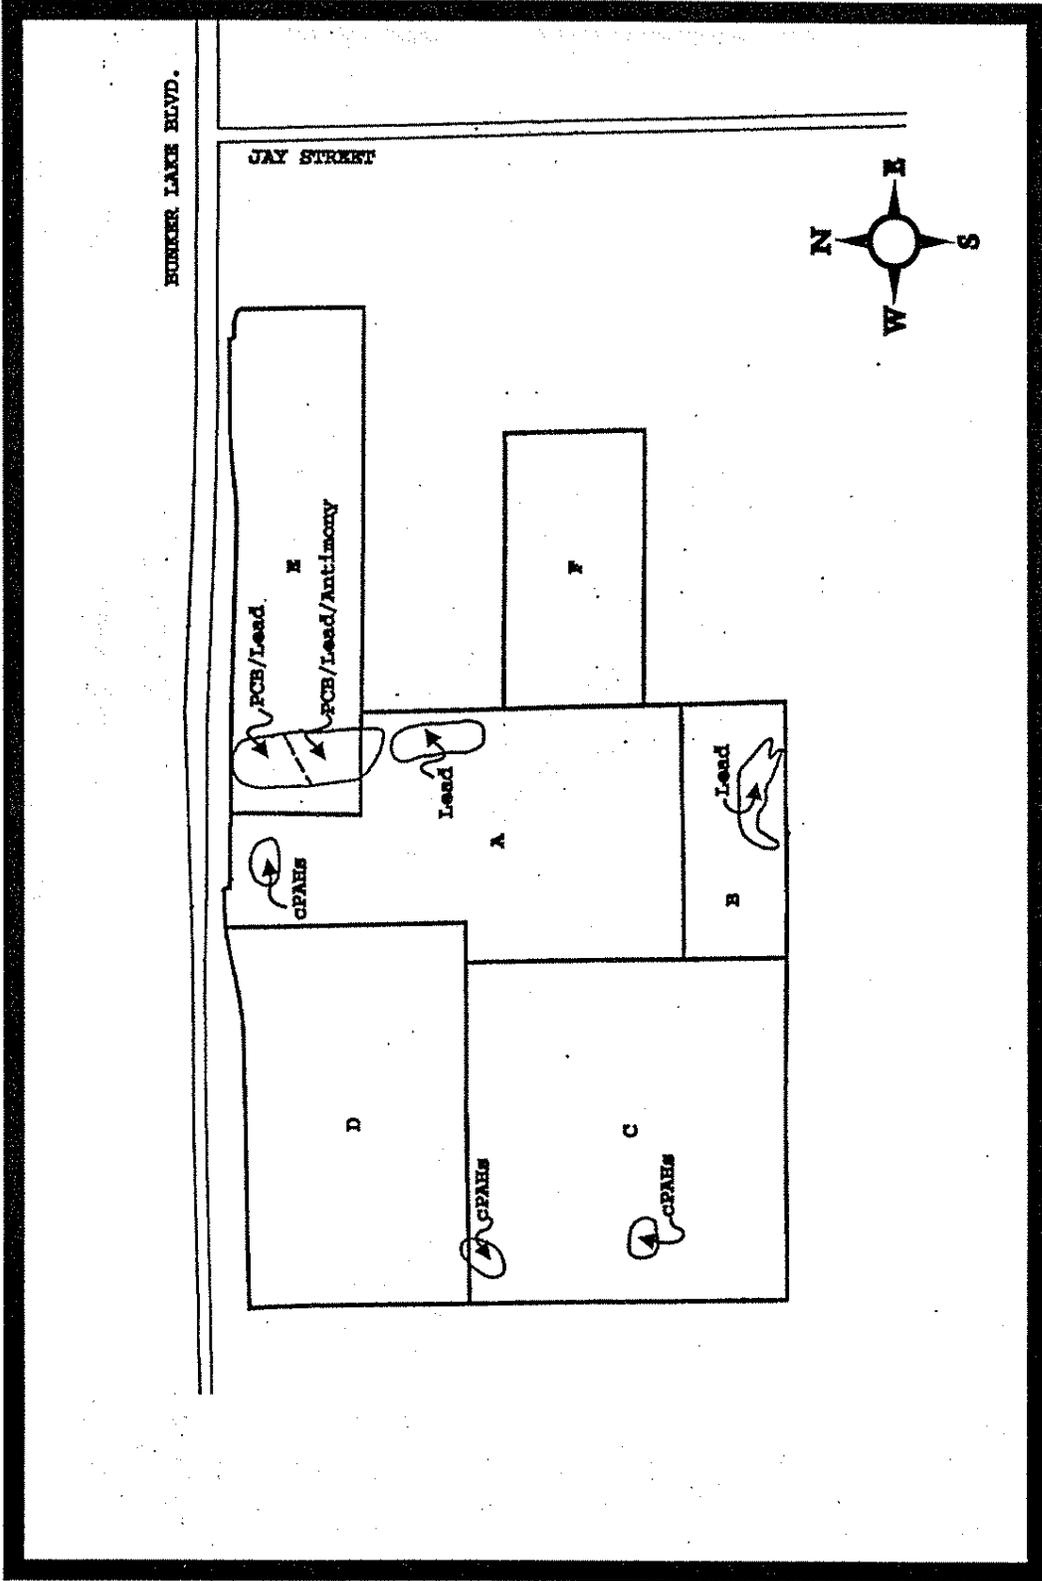
Figure 7. Soil clean up areas

The most contaminated areas of the Site's soil were characterized through various sampling studies. Those areas identified for clean up are shown in Figure 7. The amended Record of Decision (ROD) for the soil operable unit will require removal of all contaminated material above risk-based action levels followed by backfilling with clean soil obtained from off-site (CRA 1994c). This clean up activity is proposed to begin in late 1994. It includes excavation of contaminated soil, followed by removal for off-site disposal or treatment as determined by the type of contamination.

At the present time, the groundwater is being addressed through continued monitoring. The contaminated soil that poses potential risks to health will be removed from the Site and replaced with clean materials.

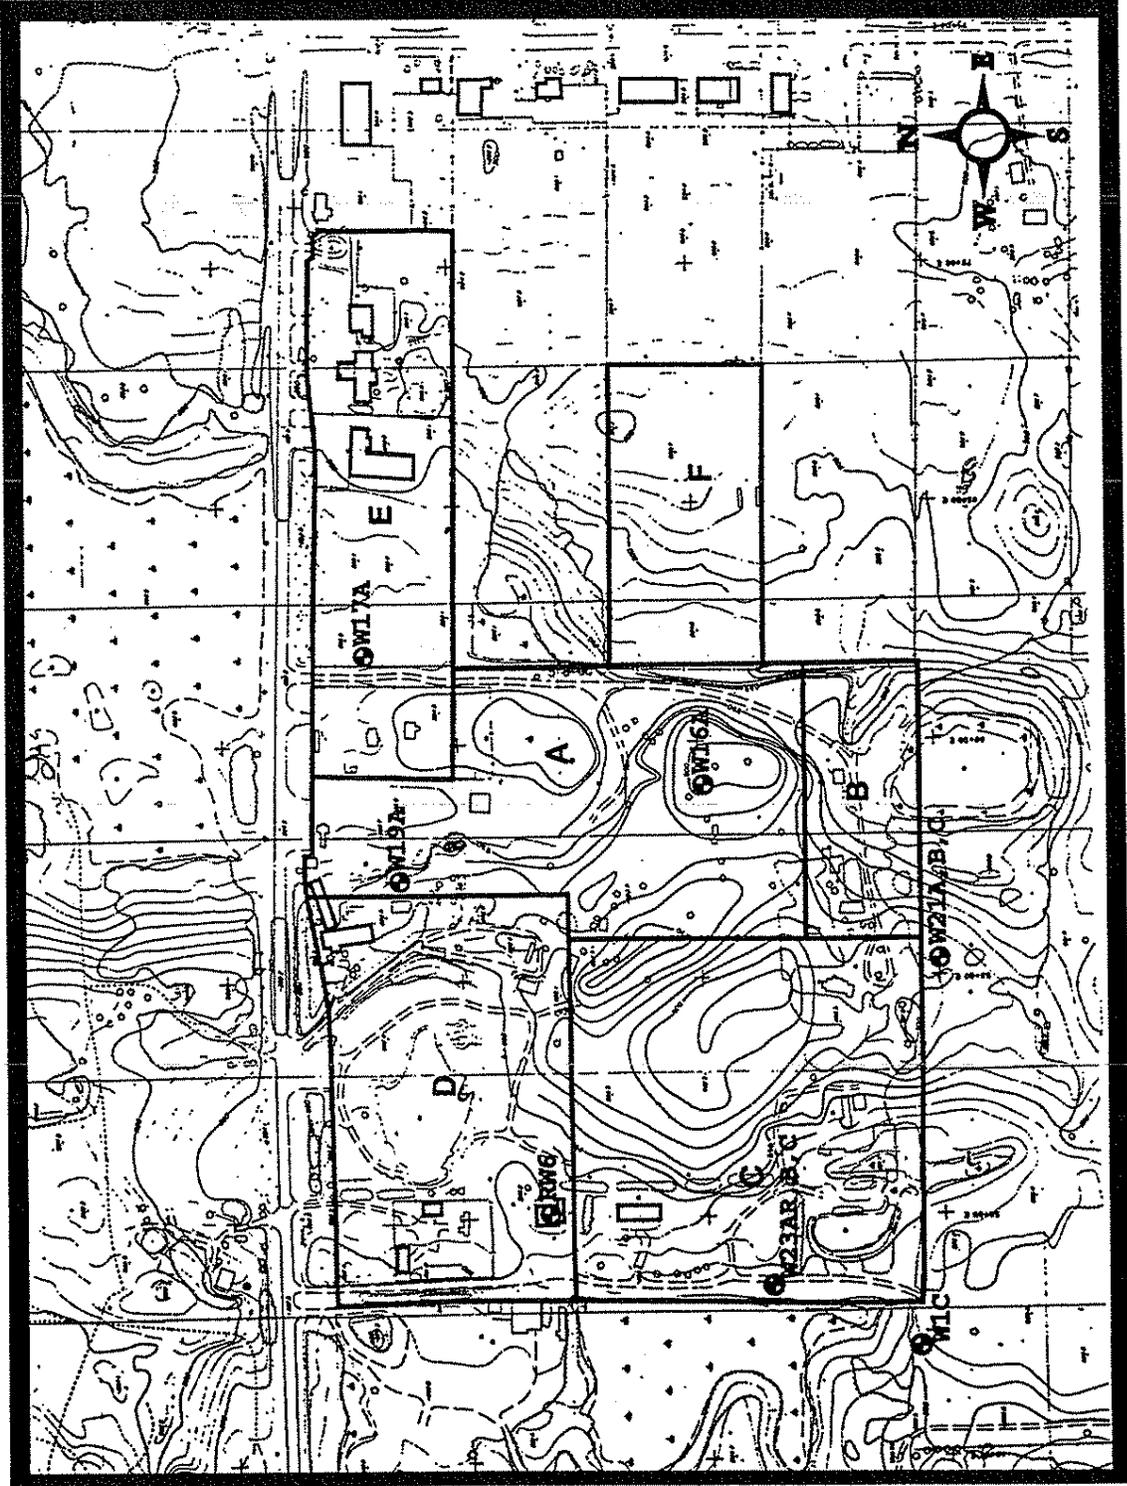
Figure 8. Groundwater sampling locations

The Baseline Risk Assessment found no health risks associated with the groundwater pathway, with one possible exception. During the DI, arsenic was found in one shallow on-Site monitoring well (21B) at 78.4 micrograms per liter ( $\mu\text{g/l}$ ), which is above past MDH guidelines for private wells (RALs) and also above the Federal MCL. Other detections of arsenic--15.3  $\mu\text{g/l}$  in a second shallow monitoring well and a range of 2.6 to 7.2  $\mu\text{g/l}$  in four Lower Sand monitoring wells-- were also reported for 1990 sampling (Donohue 1992); however, no individual source was found to account for the elevated arsenic. Most of the arsenic was found near the southwestern portion of the Site.
