# MN Hard to fix houses

## Minnesota Department of Health

# Dodge County House

# Metro Area Rambler

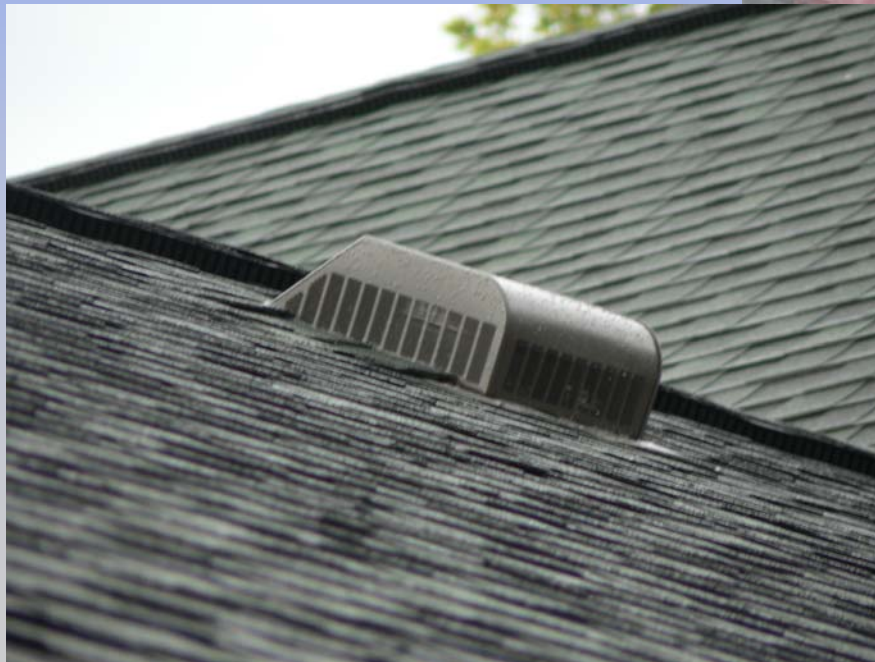
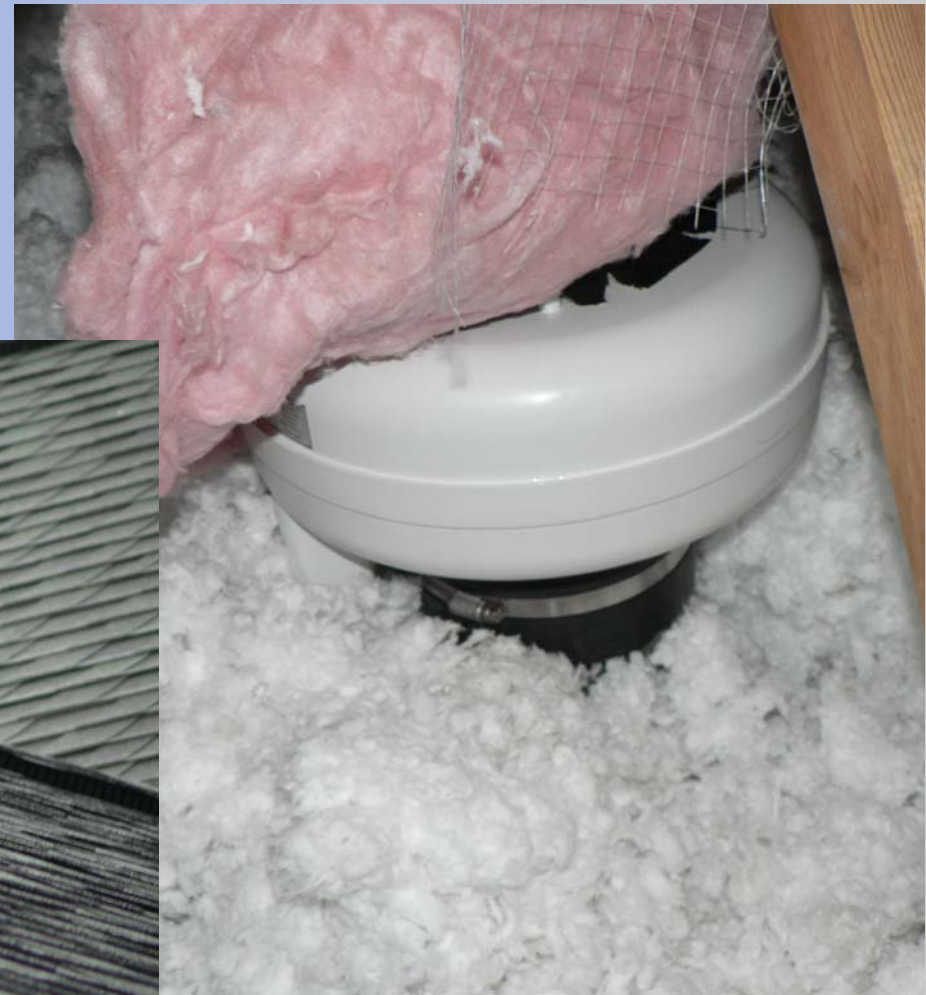
# Pressurization Mode

- ★ Added roof vent and flipped RP265

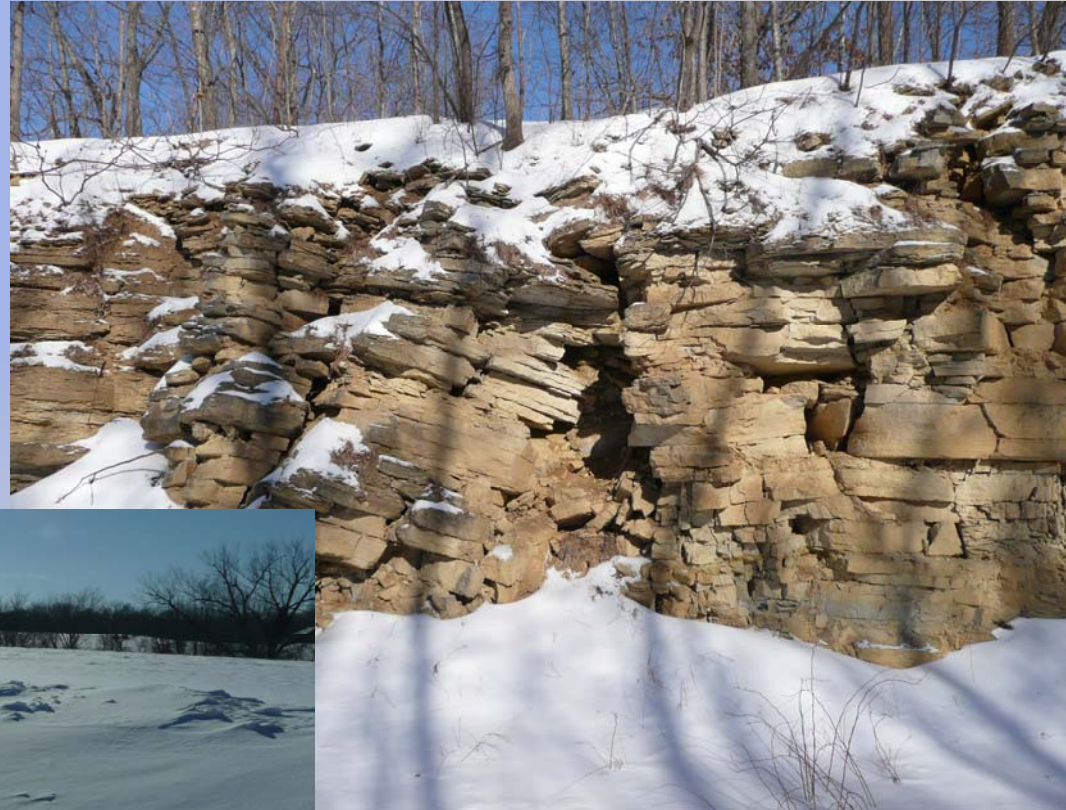
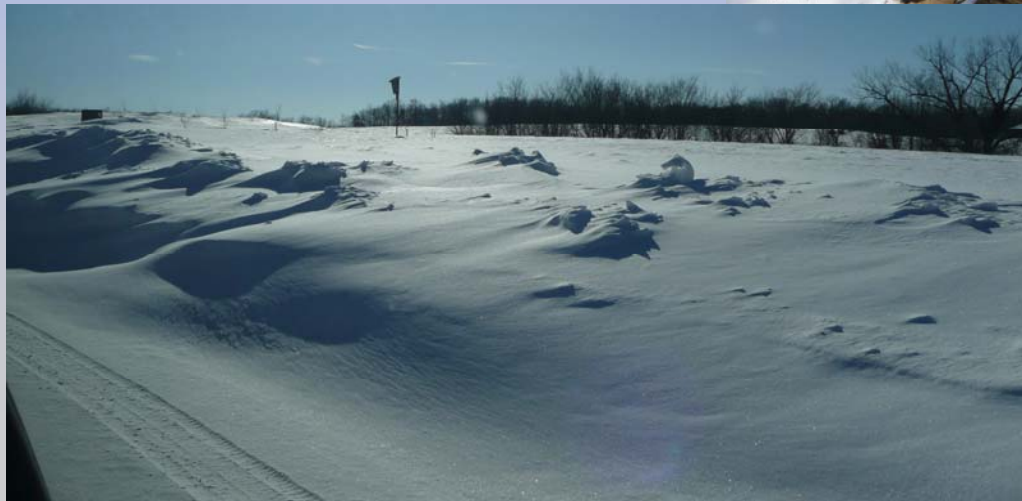
# Winter Problem

- ★ Ground Capping and the floor is turned on

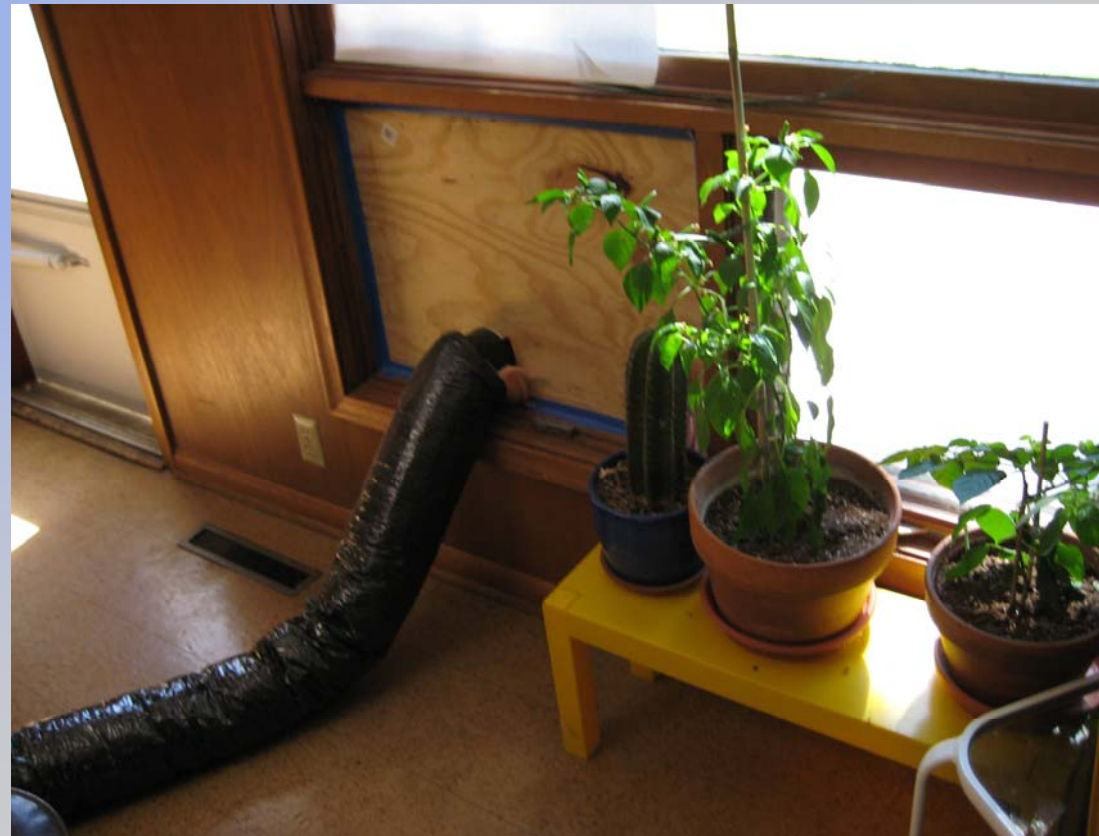
# Temp System

- ★ The temp system that was installed with a Radon Away XP 201 sucking on the sump basket and was vented through a basement window that was removed...
- ★ The beaver board was caulked closed

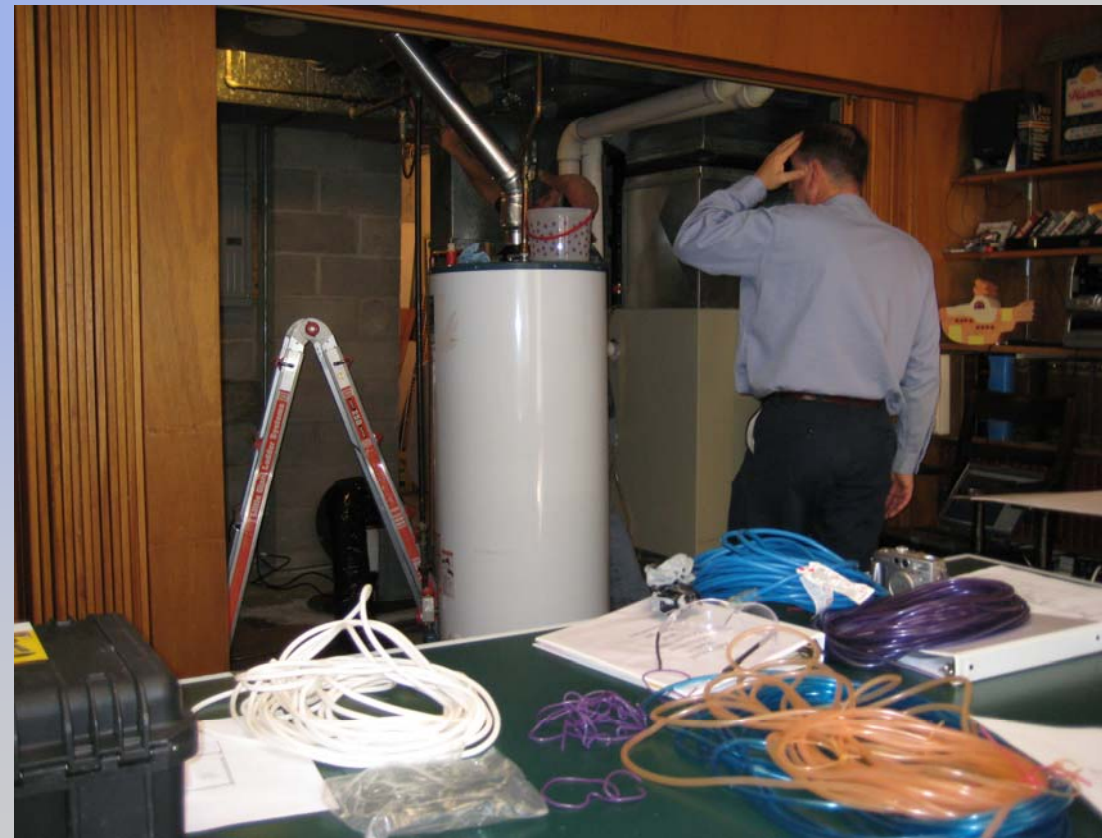
# The walkthrough

- ★ The 1 ½" PVC pipe that connects the furnace plenum and the sump basket was missed by all...

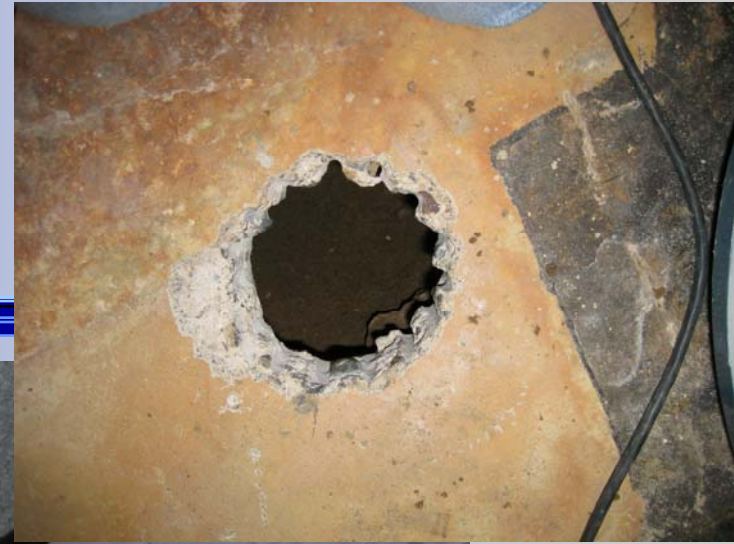
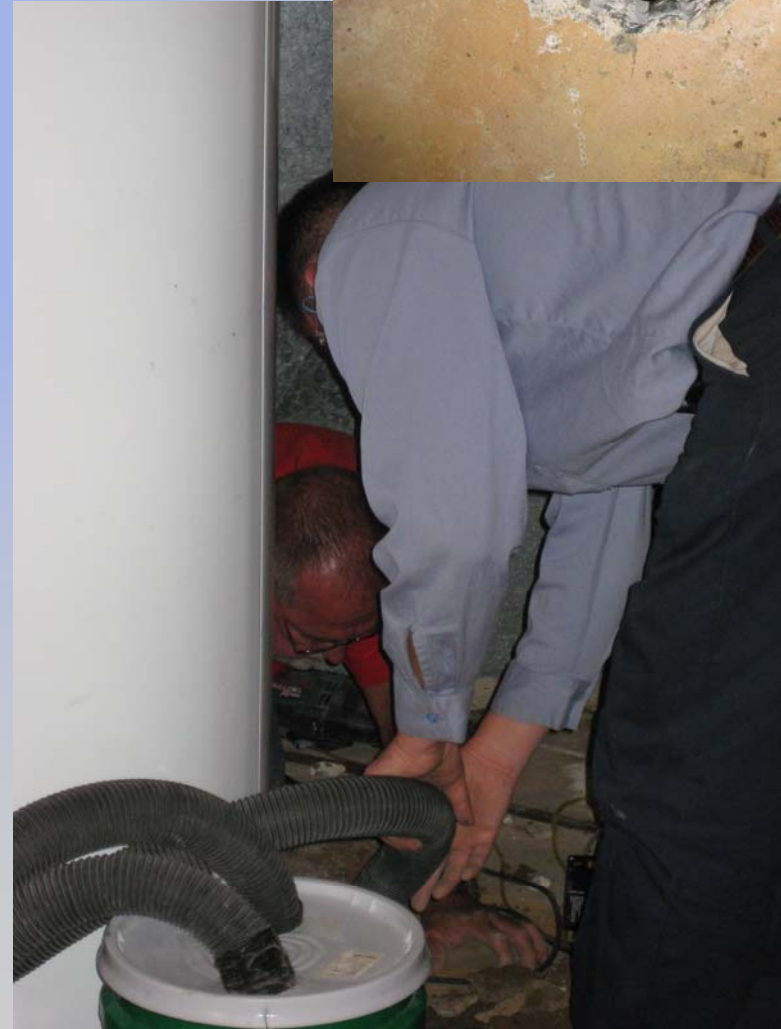
# Suction Pit

- ★ The suction pit was decided to be placed near the furnace plenum and the sump basket

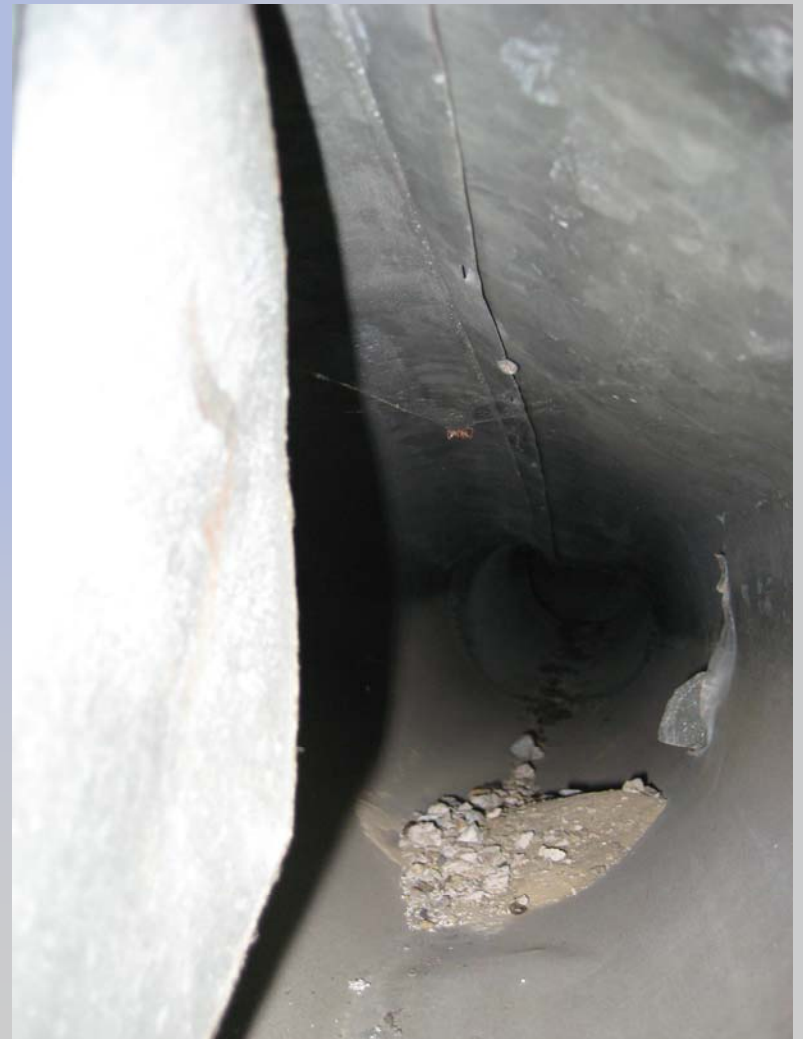
# New Pit Pressure Extension

- ★ The new pit had better pressure extension than the sump basket but it was not giving strong pressures on the ends of the house
