# Health Consultation

FORMER PARK RAPIDS DUMP

CITY OF PARK RAPIDS, HUBBARD COUNTY, MINNESOTA

SEPTEMBER 30, 2006

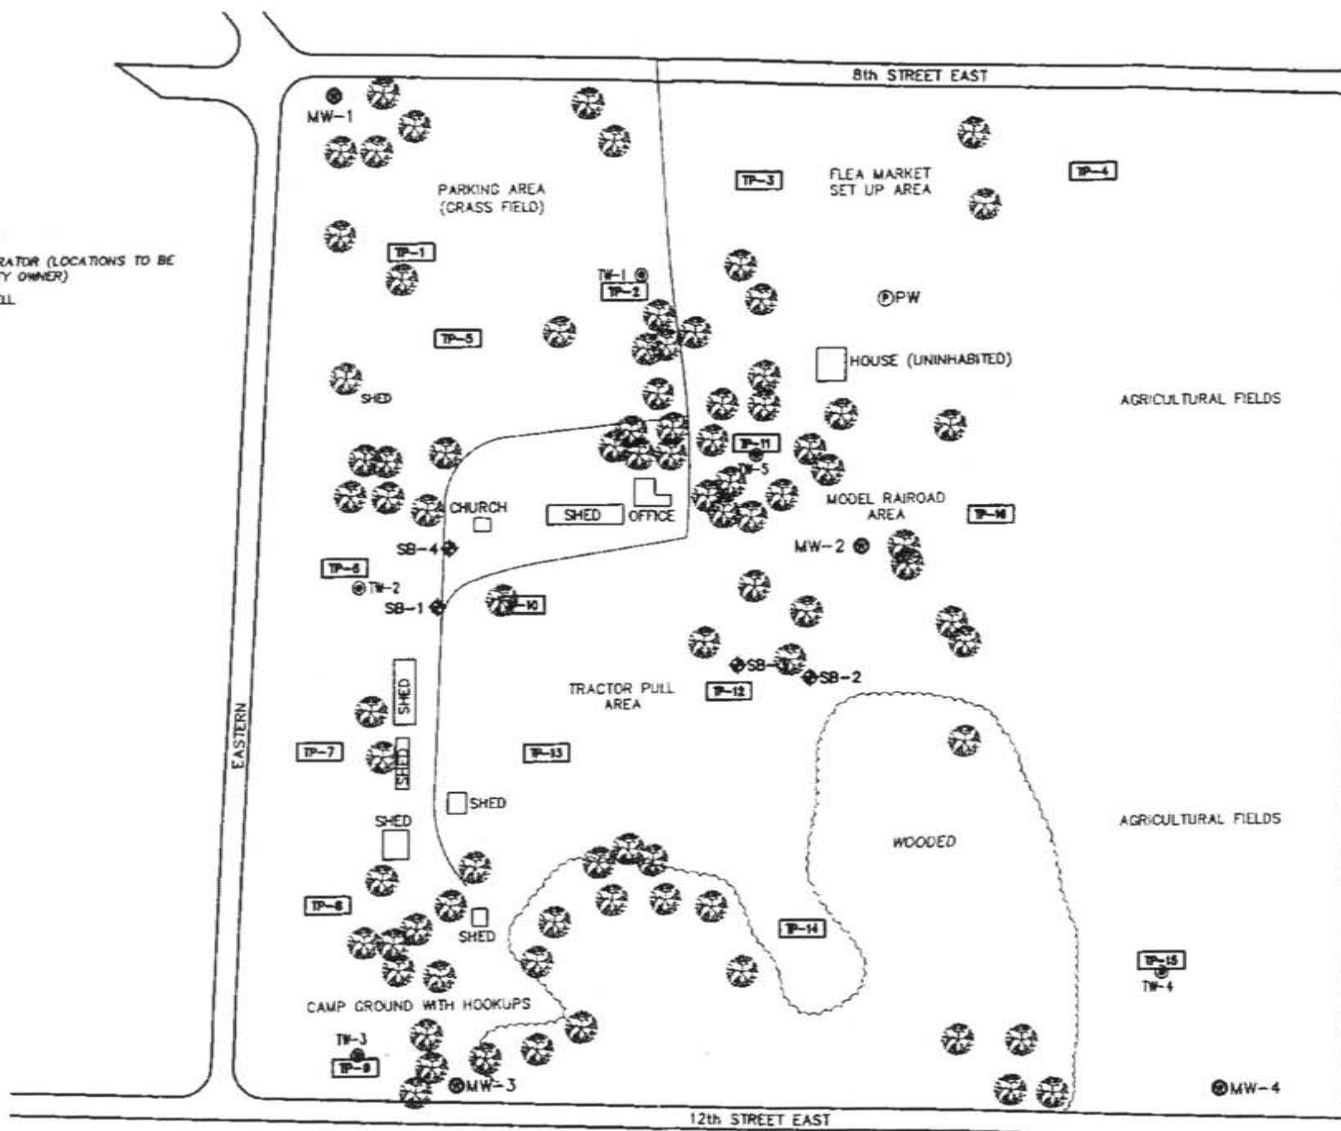
Figure 2: Site Map

A second site investigation was conducted in 2005 by STS on behalf of the MPCA and the Park Rapids Antique Tractor Club (STS 2006). The purpose of the investigation was to try to determine the nature and extent of waste materials disposed at the site. The investigation consisted of an electromagnetic survey, nine soil borings, and 16 test trenches excavated to depths of up to eight to twelve feet below ground. Five of the nine soil borings were converted into temporary monitoring wells. The soil boring, test trench, and temporary well locations are shown in Figure 2.

Ten surface soil (0-6 inches) grab samples plus one duplicate were collected from the locations where the test trenches were dug and analyzed for cyanide, PCBs, PAHs, pesticides, herbicides, diesel range organics (DRO), and metals. No cyanide, PCBs, pesticides, or herbicides were detected above the laboratory reporting limits in any of the samples. Low levels of PAHs were detected in six samples. The levels of PAHs were less than the MPCA Soil Reference Value (SRV). The SRVs represent the concentration of a contaminant in soil at or below which normal dermal contact, inhalation, and/or ingestion are unlikely to result in an adverse human health effect. The MPCA recreational SRVs were selected as the appropriate values for comparison with site data. Low levels of DRO (14-20 mg/kg) were found in three of the samples. There is currently no soil screening criterion for DRO. Elevated levels of metals were also found in many of the samples. Levels of copper, iron, and mercury exceeded their respective SRVs in one or more samples. Copper and iron are commonly found in soil. In Minnesota, concentrations range from one to 802 mg/kg with a mean of 12 mg/kg for copper and 43 to 20,826 mg/kg with a mean of 1,123 mg/kg for iron (MPCA 1990). It is unclear if the high levels of copper and iron found are strictly related to the waste materials in the dump or reflect, at least in part, naturally occurring metals. The mercury detection (7.6 mg/kg in TP-8) significantly exceeded its SRV of 1.2 mg/kg, and is unlikely to be from natural sources. The results of the surface soil samples can be found in Table 2; the sample locations are shown in Figure 2.

TEST PIT / SOIL BORING & WELL DIAGRAM  
 FORMER PARK RAPIDS DUMP SITE  
 12th STREET EAST & HENRIETTA AVENUE  
 PARK RAPIDS, MINNESOTA  
 FOR: MINNESOTA POLLUTION CONTROL AGENCY

During the 2005 STS investigation, groundwater samples were collected from five temporary monitoring wells installed in soil borings at the site. Locations are shown in Figure 2. The samples were analyzed for metals, cyanide, PCBs, PAHs, DRO, pesticides and herbicides. No cyanide, PCBs, PAHs, DRO, pesticides or herbicides were found above laboratory detection limits. Manganese was the only metal detected, and was found in four of the five samples at levels ranging from 5.8 to 51.4 micrograms per liter (ug/L). These levels are well below the MDH Health – Based Value (HBV) for manganese of 1,000 ug/L. MDH has developed HBVs and Health Risk Limits (HRLs) for drinking water. The HBVs and HRLs represent levels of contamination in drinking water supplies that MDH considers safe for daily human consumption over a lifetime. The HRLs have been promulgated into rule, while the HBVs have not.

Groundwater samples were collected by STS on two occasions from the four permanent monitoring wells installed at the site. The monitoring well locations are shown in Figure 2; the data are presented in Table 5. These samples were analyzed for metals, cyanide, PCBs, PAHs, DRO, herbicides and pesticides. The metals samples were filtered in the field. No VOCs, PAHs, PCBs, herbicides, pesticides, or cyanide were detected in the monitoring well samples. DRO was detected at a level of 180 ug/L in a duplicate sample from MW-2. This level is below the MDH HBV of 200 ug/L. Metals, primarily manganese and thallium were detected in groundwater samples. The level of manganese was well below its HBV. Thallium levels exceeded the HRL for thallium of 0.6 ug/L in all but one of the monitoring well samples. Thallium concentrations ranged from 18.1 to 30.5 ug/L, with a relatively high detection limit of 15 ug/L.

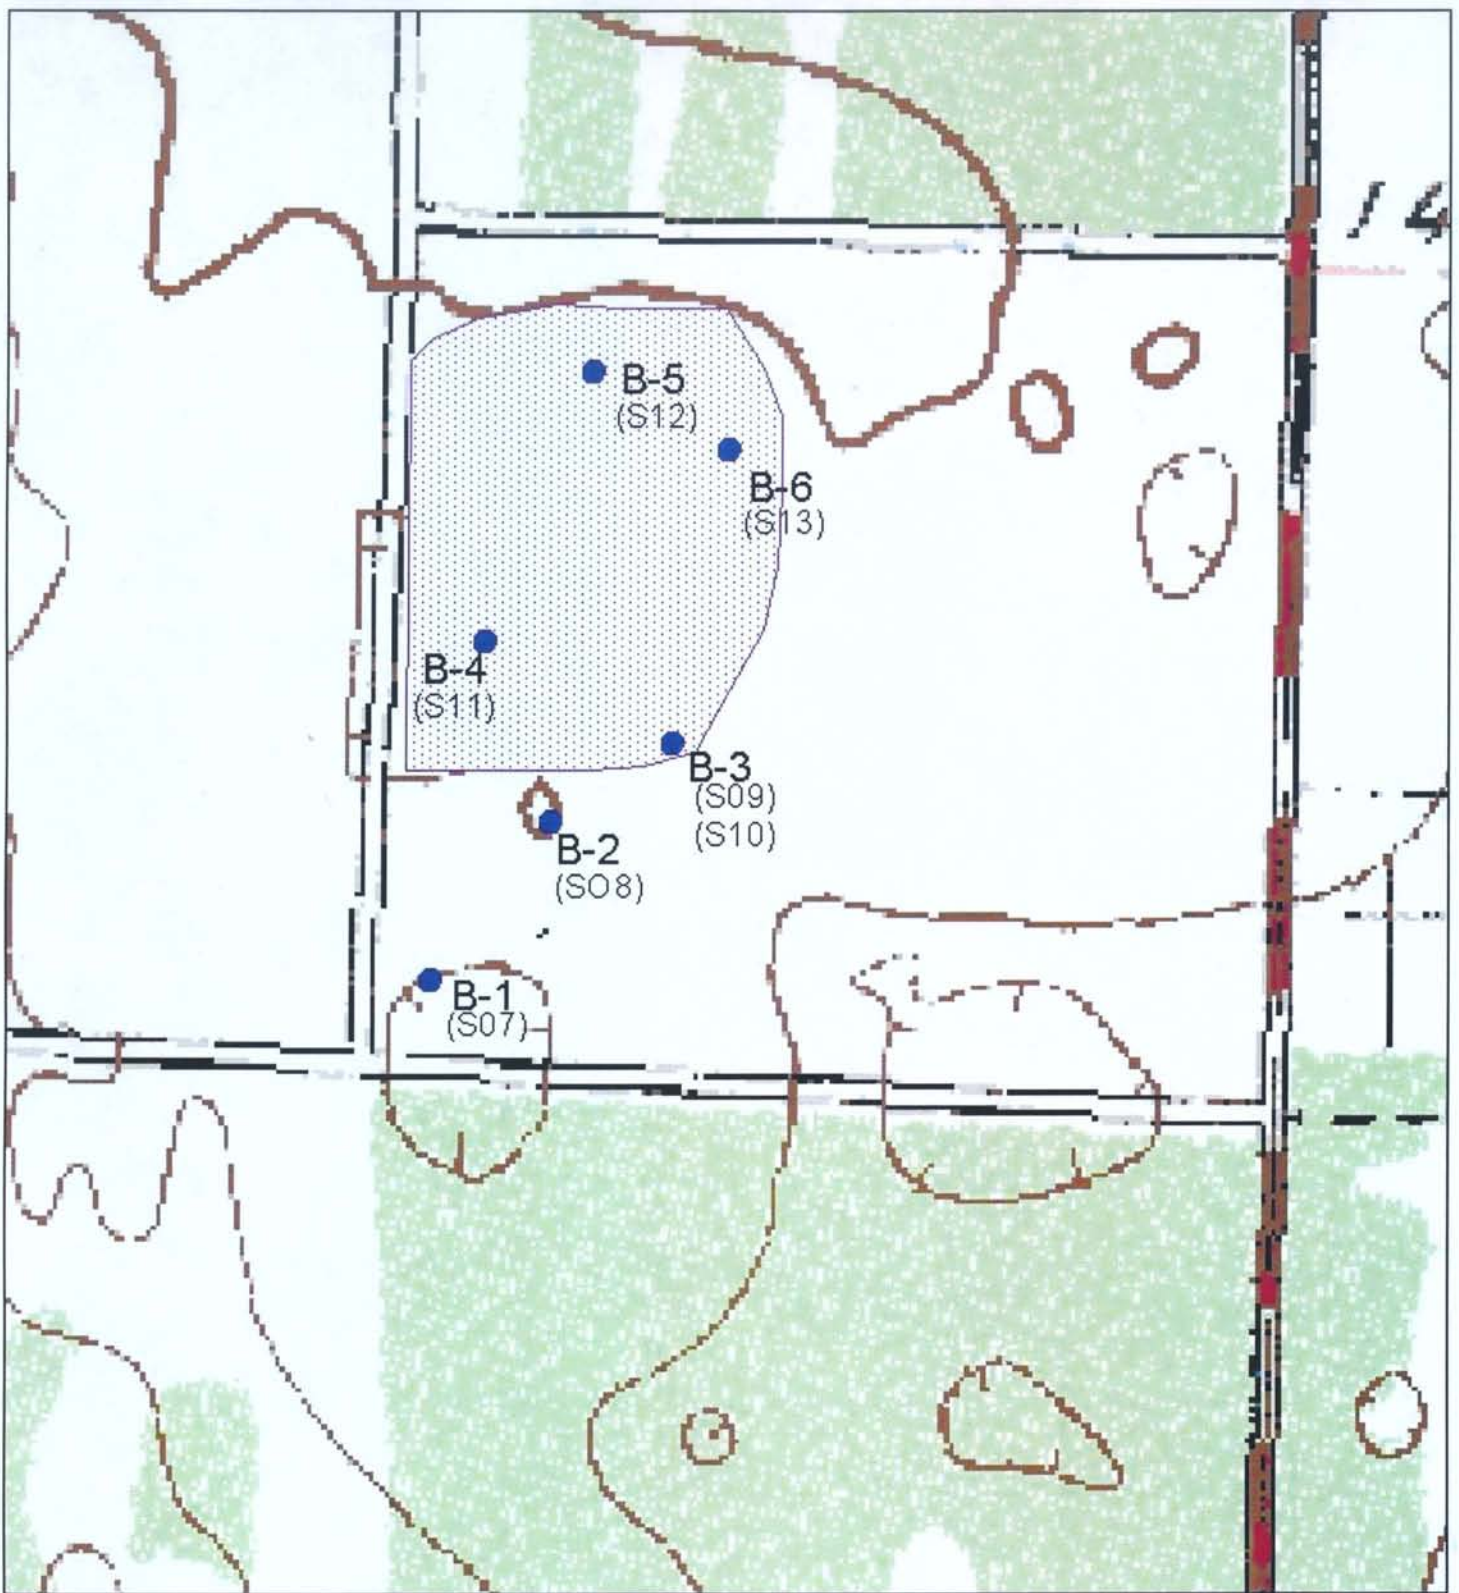
**Figure 3: 1990 MPCA Soil Investigation Borings**

In March of 1990, the MPCA drilled six soil borings on the site. Four borings were completed to a depth of 15 feet, one to 35 feet, and another to 55 feet. The borings generally encountered 0-2 feet of soil and/or up to 13 feet of refuse/fill, overlying at least 40 feet of fine to medium grained sand with varying amounts of silt and gravel and occasional silt or clay lenses. Waste was encountered in only four of the borings (B-3, B-4, B-5, and B-6), with only one boring (B-4) advanced through the main portion of the dump. An organic vapor monitoring device was used to screen the soil during drilling, but did not detect any measurable organic vapors. The locations of the 1990 MPCA soil borings are shown in Figure 3.

● Approximate location of soil borings  
(numbers in parantheses are sample numbers)

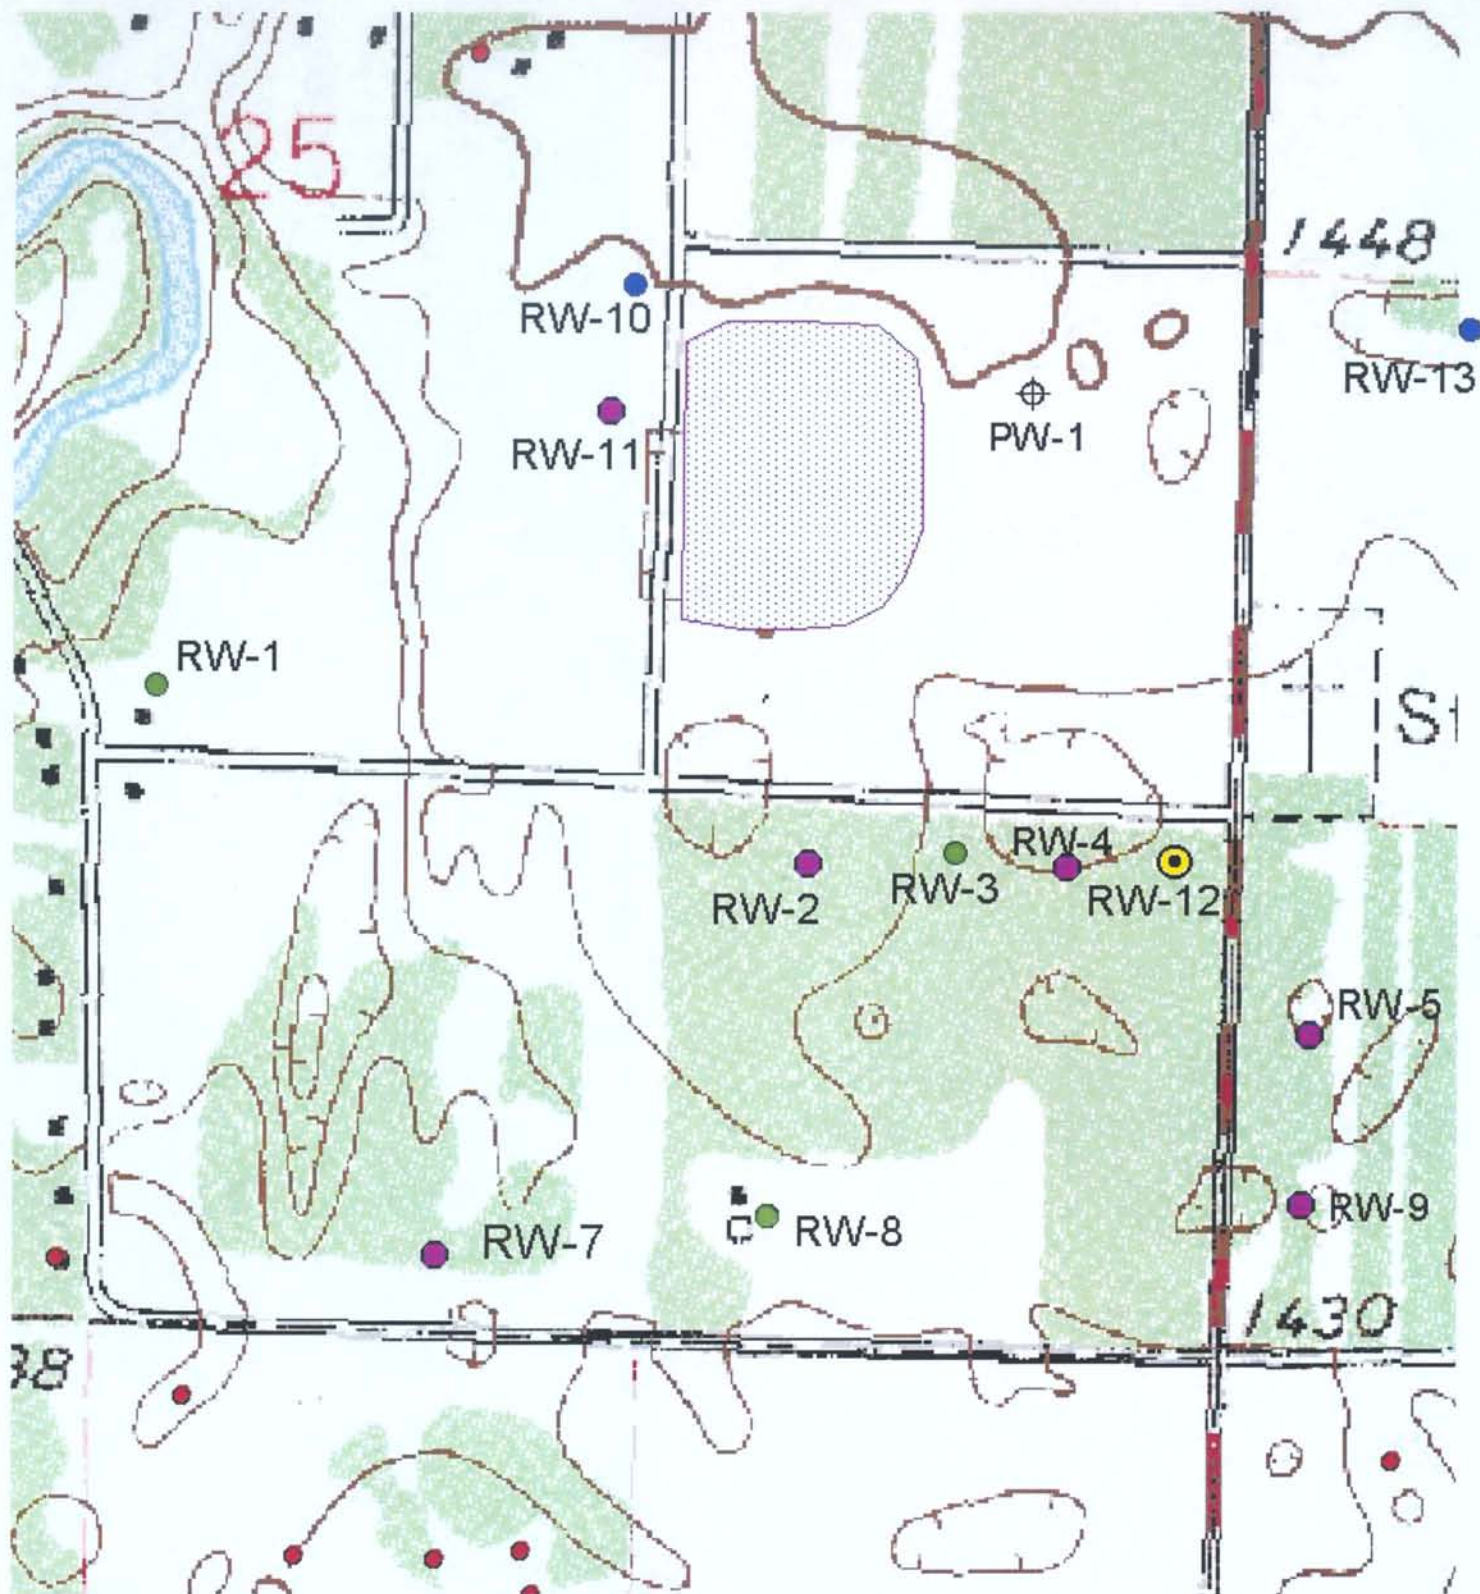
Figure 4: Private Well Sample Location Map

Of the metals detected, seven were present at what could be considered elevated concentrations, but only two (silver and thallium) exceeded the current drinking water standard. Two wells (RW-1 and RW-12) had concentrations of thallium that exceeded the current HRL of 0.6 ug/L (2.7 and 2.3 ug/L, respectively). One well, RW-4, had concentrations of silver (73.1 ug/L) that exceeded the current HRL of 30 ug/L. All other metals were below the HRLs, and appear to be within normal background concentrations (except for some elevated zinc and lead levels, which were slightly above background). The locations of the 1990 (and later) private well samples are shown in Figure 4, and the metals data are shown in Table 6.

In March of 2003, MDH collected a sample from one private well located immediately south of the site, designated RW-12 in Figure 4. In June of 2003, MDH also collected a sample from the on-site well at the tractor club. The samples were analyzed for VOCs, metals, nitrates, and general chemistry parameters by the MDH laboratory. The metals data are presented in Table 6. Thallium was not one of the metals included in the analysis. In residential well RW-12, nitrate nitrogen was detected at a concentration of 3,800 ug/L. The MDH HRL for nitrate nitrogen is 10,000 ug/L. Low levels of barium and copper were also detected in the sample from RW-4. In the well located on the site, chloroform was detected at very low levels. The chloroform may have been produced as a result of chlorine bleach used to disinfect the well and distribution system each spring, a practice reported by the tractor club members. Chlorine can combine with natural organic material in water to form chloroform. Nitrate and multiple metals were also detected in the samples, none at concentrations exceeding the HRL.
