# MN Hard to fix houses

## Minnesota Department of Health

# Dodge County House

# Metro Area Rambler

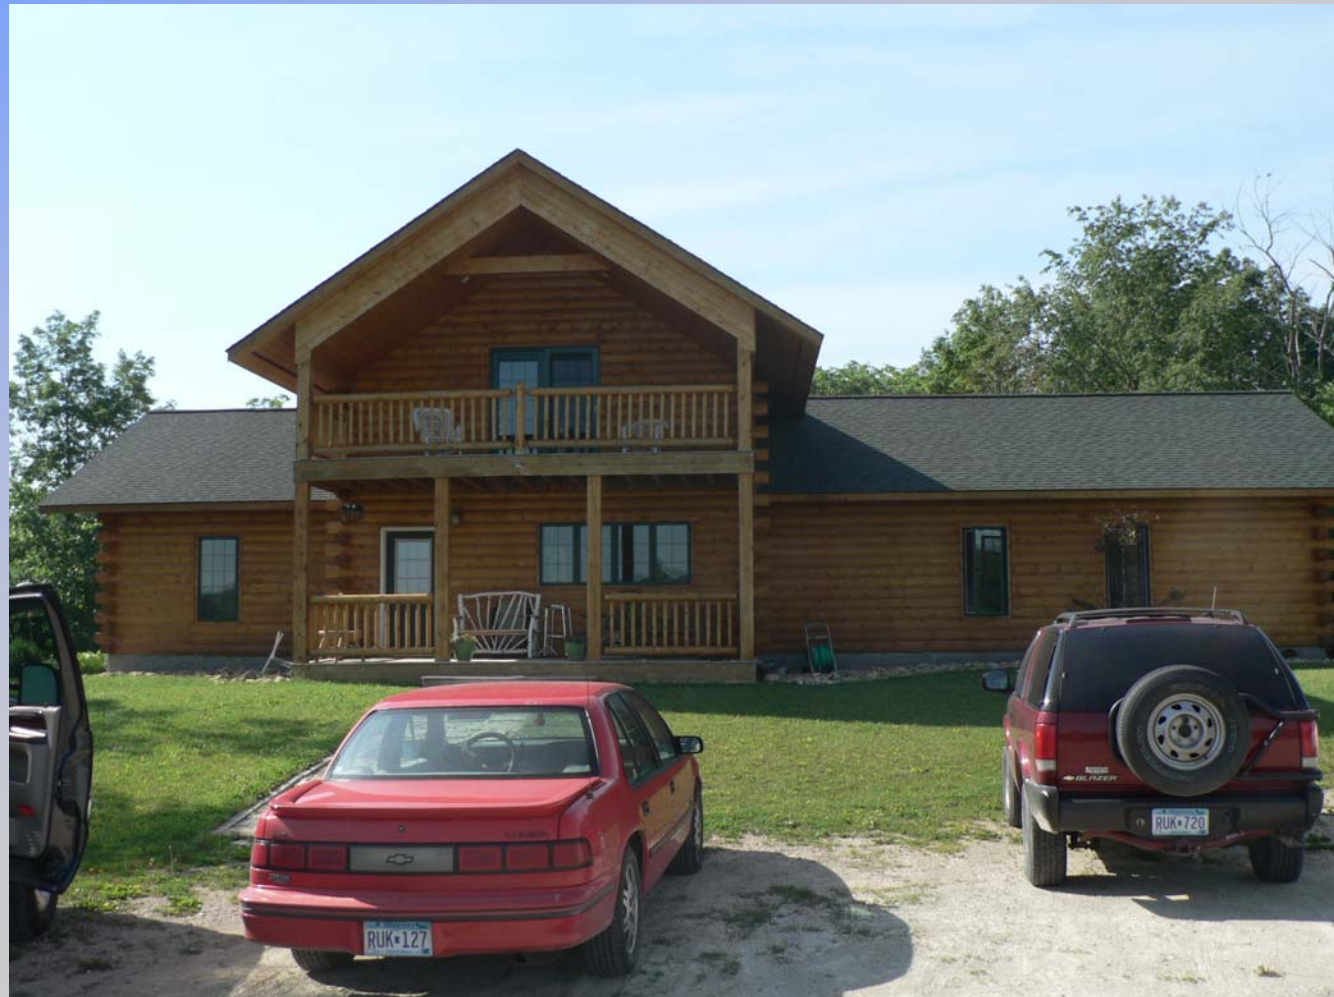
# Front of house

## ✓ *House Problems*

✓ *Log home*

✓ *Wood Foundation*

✓ *Day-lighted exterior draintile*

✓ *In-floor heat*

✓ *Limestone Cave below house*

✓ *House on top of hill, surrounded by sink holes and open land*

✓ *Radon levels 130 pCi/L to 160 pCi/L*

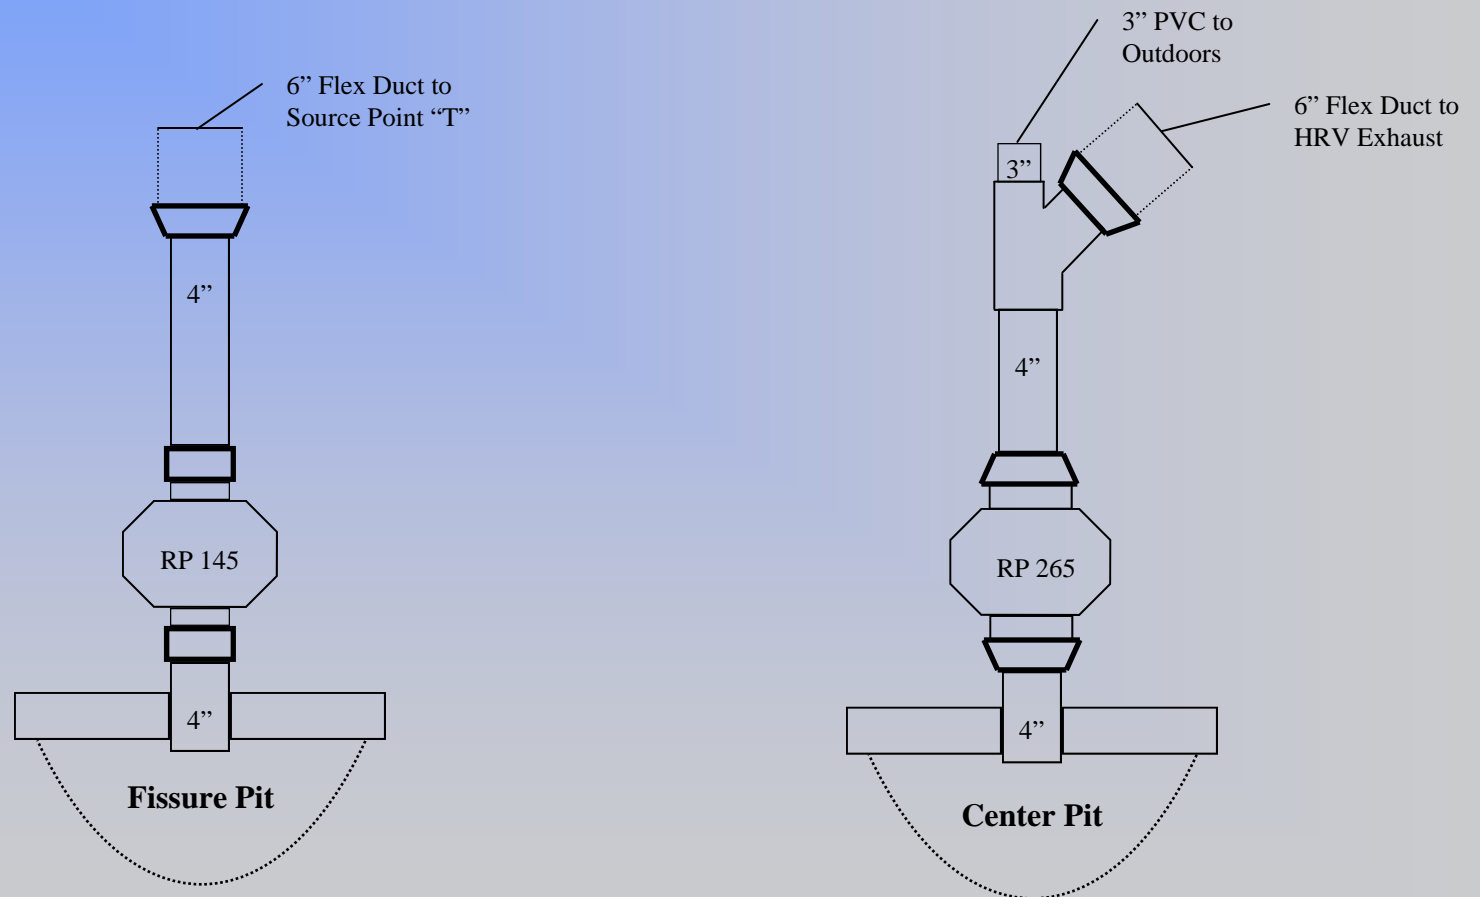
# Pressurization

Pressurizing below the slab reduced summer levels but could not reduce winter levels below 17 pCi/L

- ★ Added roof vent and flipped RP265

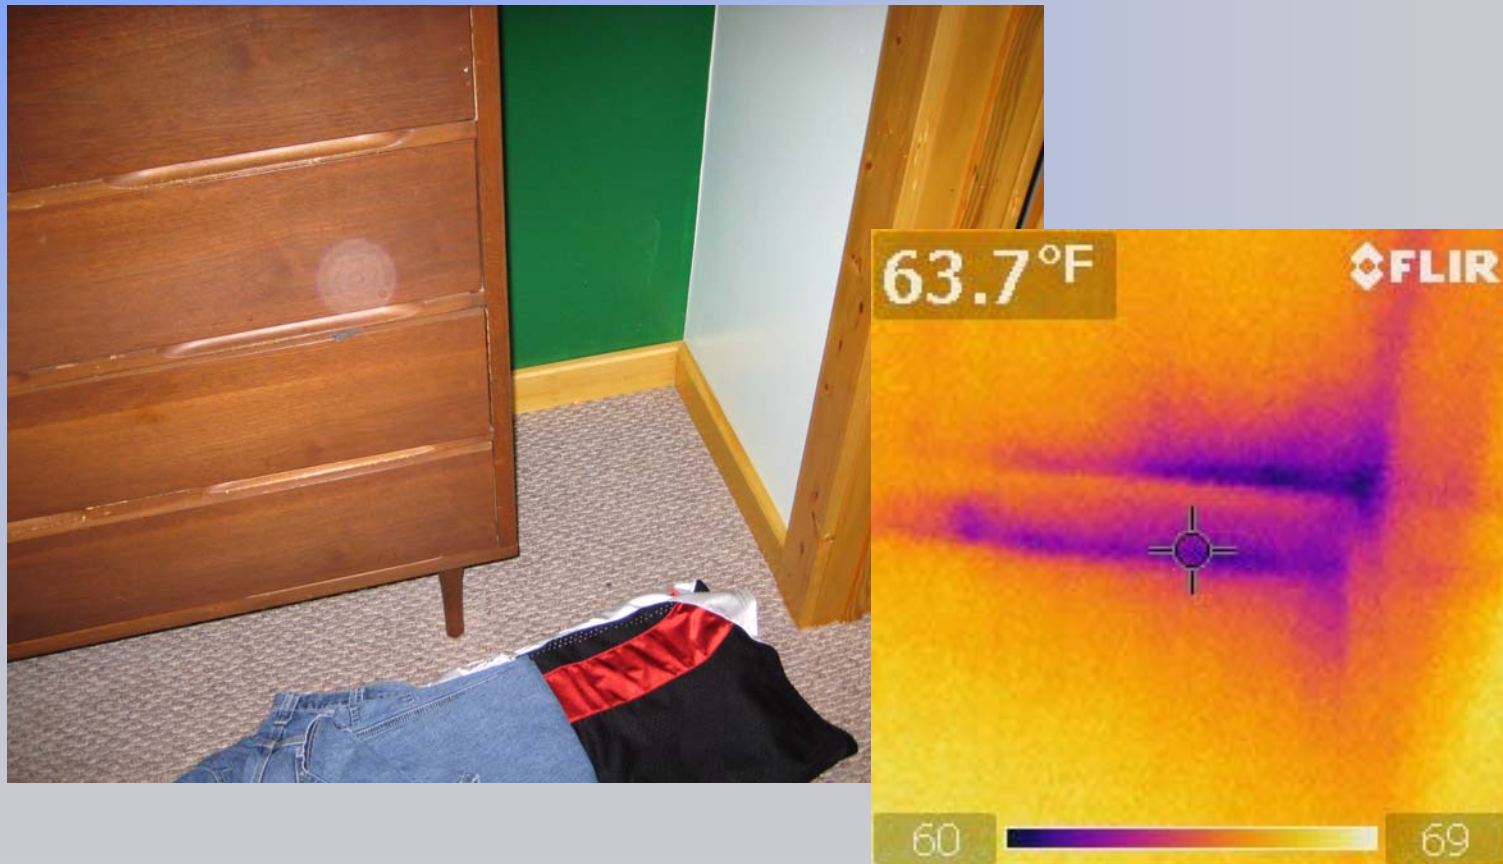
# Infrared Diagnostics

- ★ Homeowner was not proactive...
- ★ Further diagnostics testing motivated homeowner, A infrared camera and blower door were needed to show the leakage from the soil.

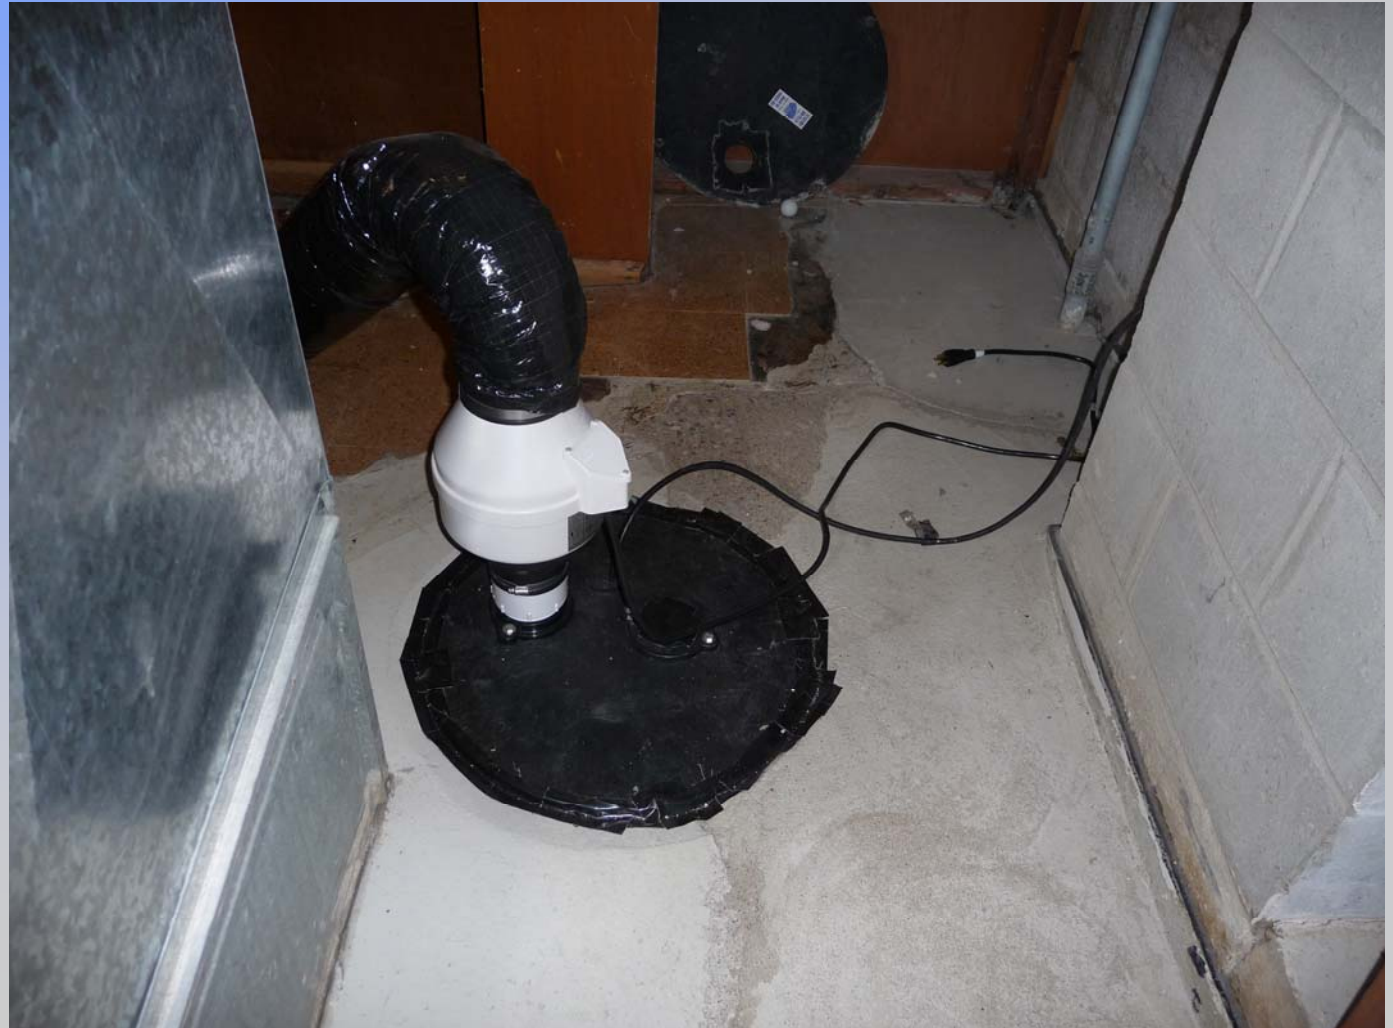
# Temp System

- ★ The temp system that was installed with a Radon Away XP 201 sucking on the sump basket and was vented through a basement window that was removed...
- ★ The beaver board was caulked closed

- ★ Although the beaver board was caulked well the sump basket was only taped closed and none of the 1/8"-1/4" cracks within a 5' radius of the sump were not sealed

- ★ The large cracks around the sump basket were sealed, the sump basket caulked closed...

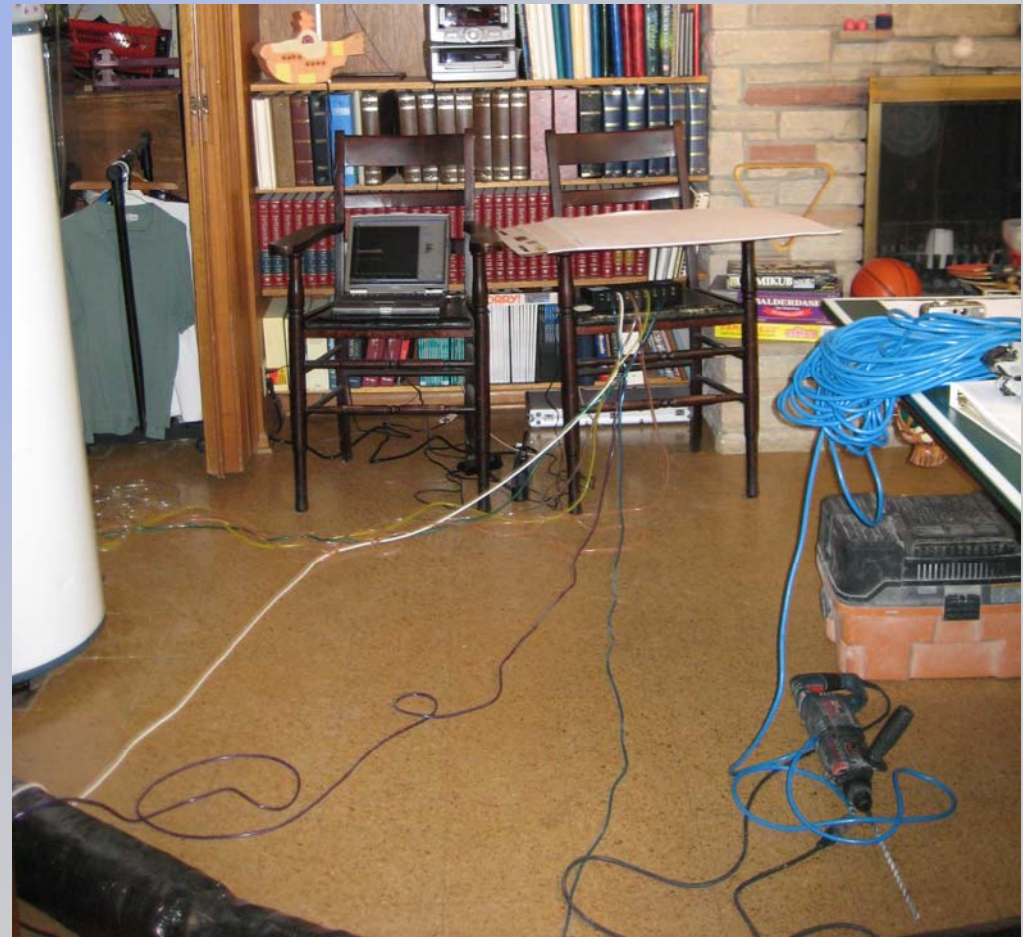
# Pressure Extension Measurements

- ★ To make the pressure extension visual we used a computer, and APT 8...

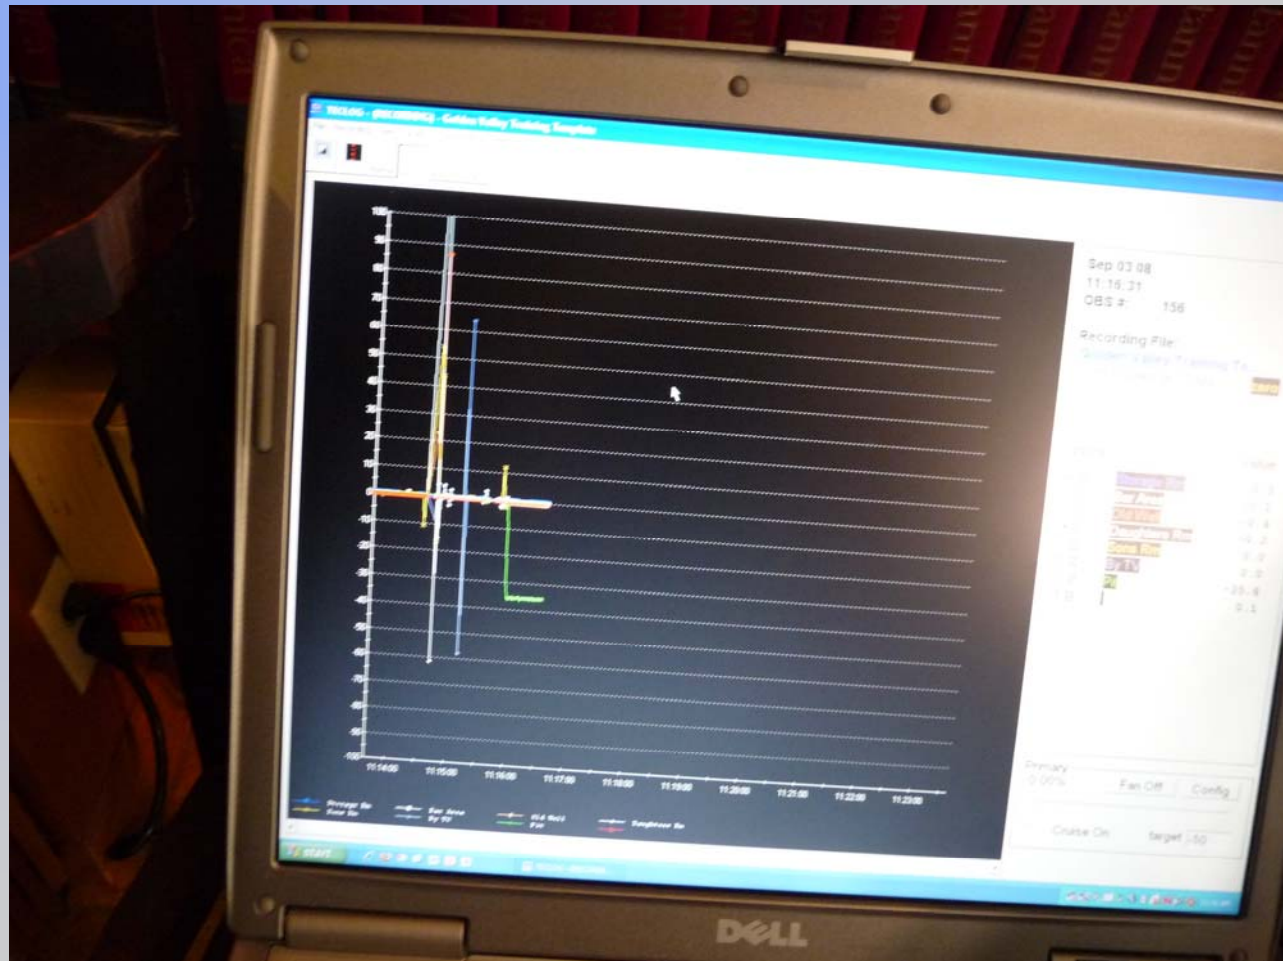
# Pressure Diagnostics

★ Teclog
