NEWS AND INFORMATION

FOR PUBLIC WATER SUPPLIERS IN MINNESOTA

## Minneapolis Keeps Up with Distribution System Renovation

## Minneapolis Distribution Crews Maintain Critical Infrastructure

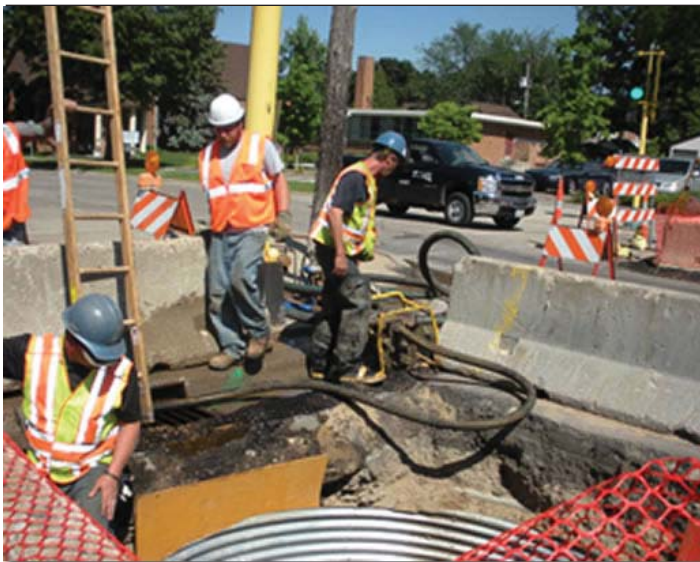
The city of Minneapolis is cleaning and lining more than 39,000 feet of its distribution system this summer. One of the projects is along Johnson Street in northeast Minneapolis. See page 2 for the story.

Two factors govern the selection of project locations. One is an opportunity to perform work in conjunction with street construction. The other is the magnitude of the problem. Minneapolis crews are working with a contractor, Heitkamp, Inc. of Watertown, Connecticut, on a project along and around Johnson Street in northeast Minneapolis, an area that has had many problems with red water. City crews maintain control of the water during the project, which includes installation of temporary water lines from hydrants from adjacent blocks as they take hydrants out of service on the block currently under construction.

Heitkamp performs the rehabilitation work, using metal scrapers to clean the pipe and then installing a cement

mortar lining. The pipe in this area was installed in 1906. Although the cleaning and lining of a total of 12,150 feet of pipe, divided into two phases, takes fewer than two weeks, the overall project—which includes excavation and associated work—began in late April and will be completed in mid-October.

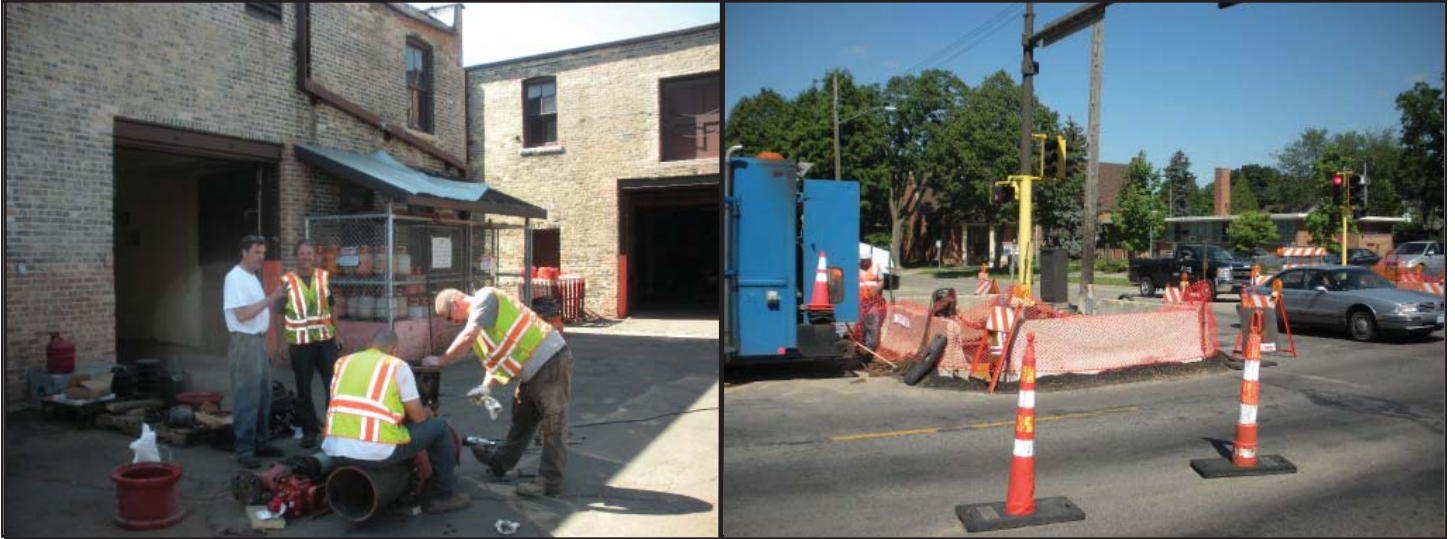
Crews from Minneapolis Water Works shown at the distribution yards in southeast Minneapolis and on the job site in northeast Minneapolis. Shown in the lower right are Mark Ebert, Bob Ervin, and Marie Asgian.
